TS-AMD-87615-25
May 1988

AERIAL PHOTOGRAPHIC ANALYSIS OF THE REFINED METALS CORP.

Indianapolis, Indiana

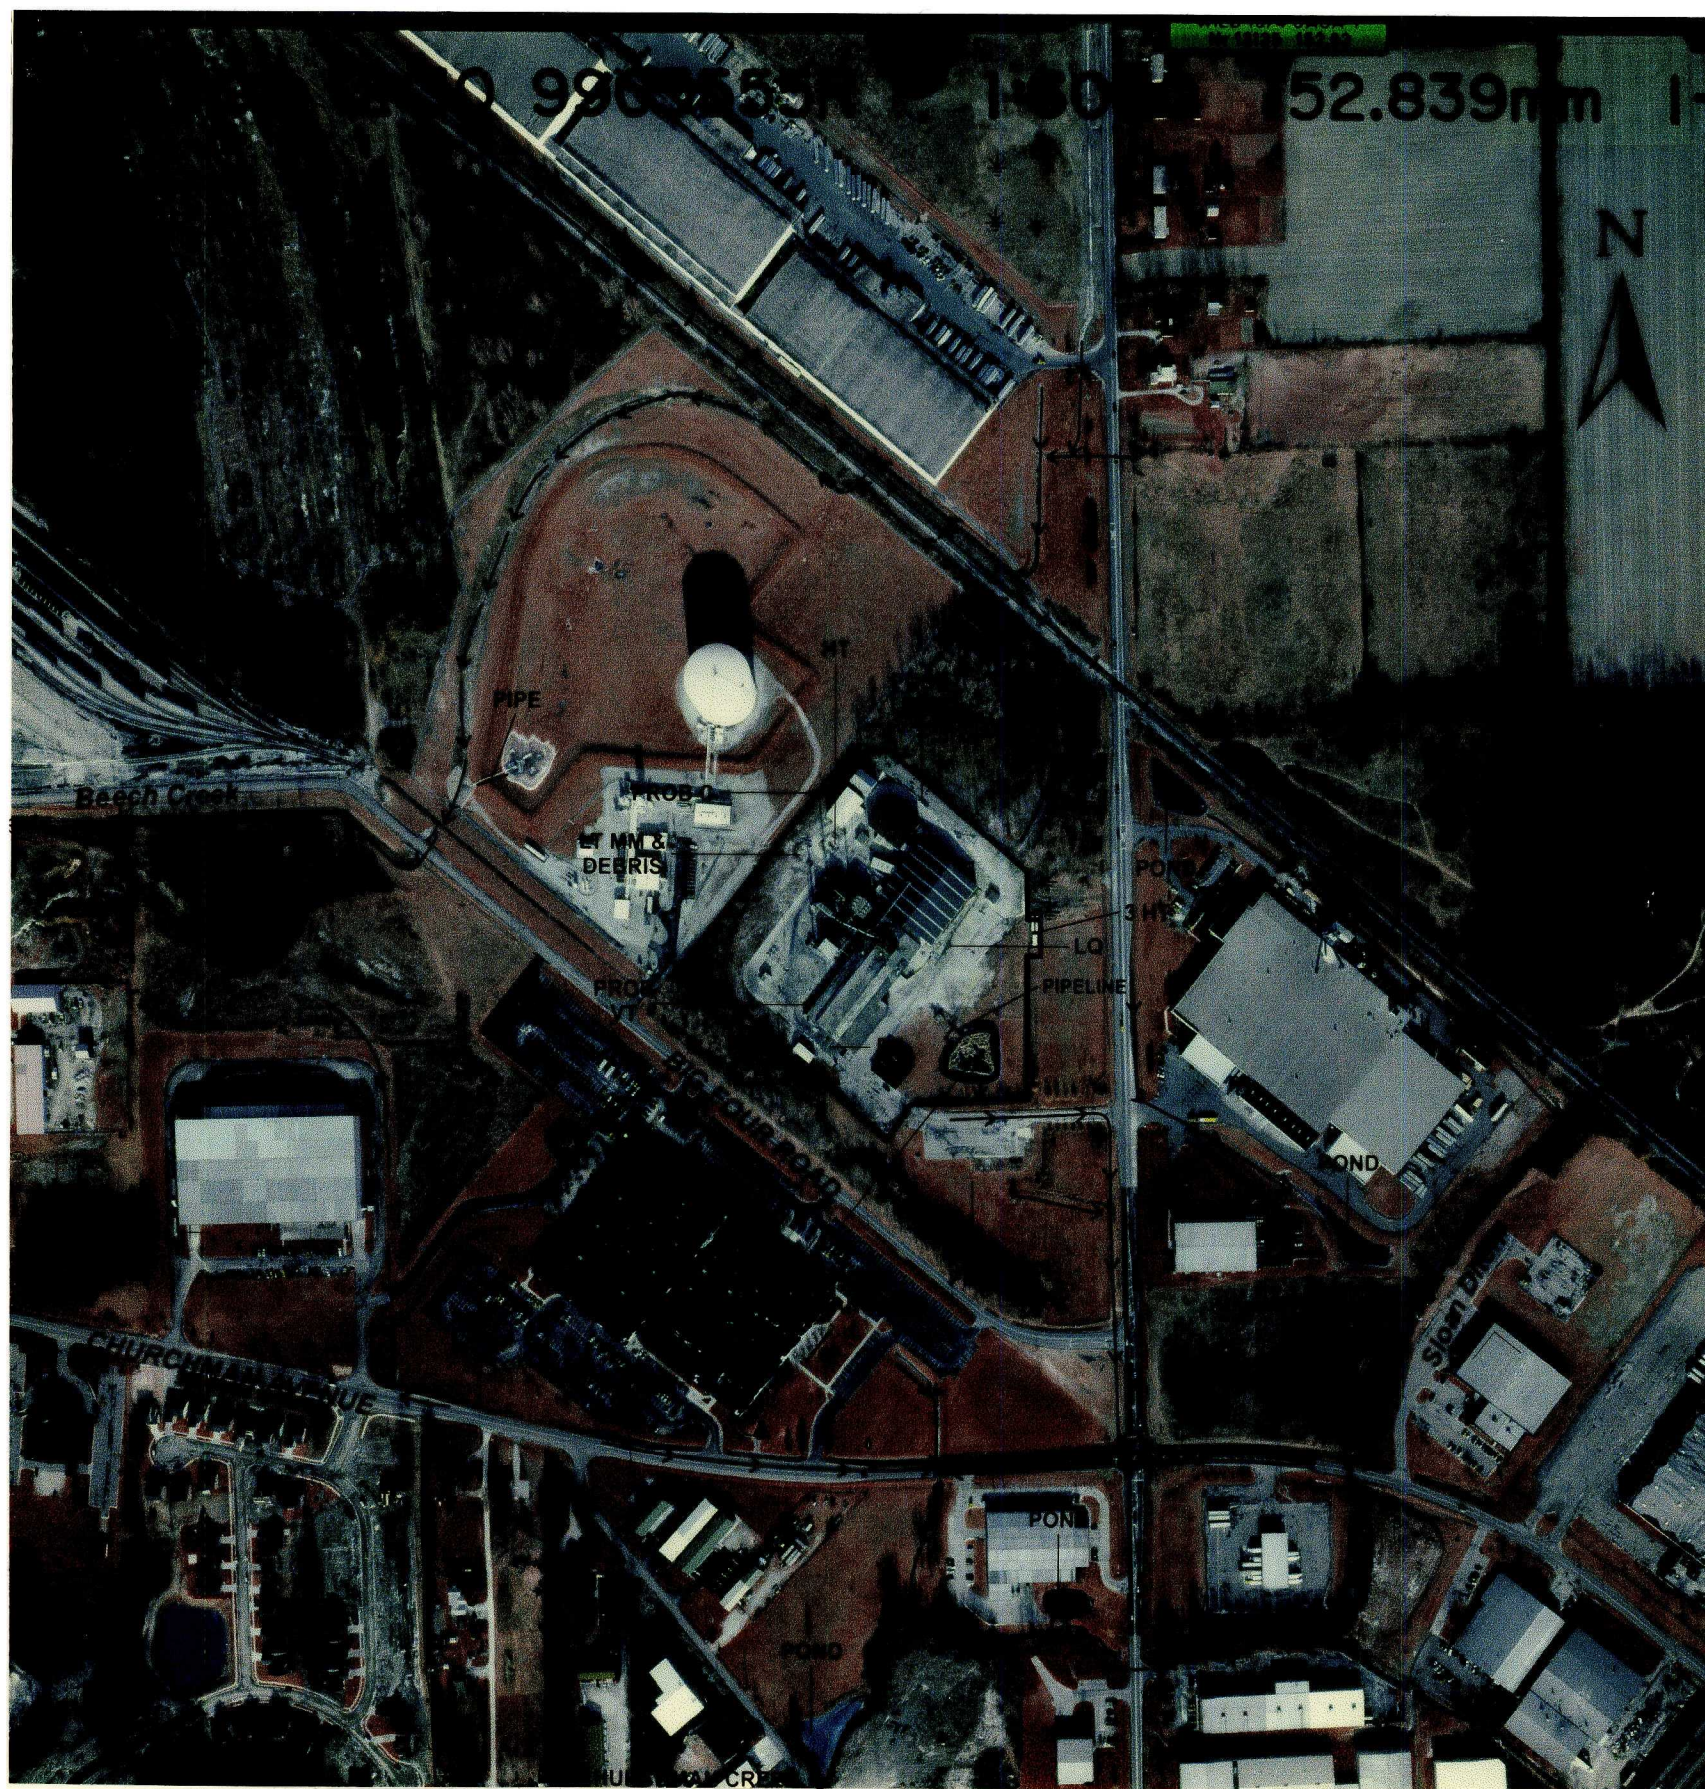
FIGURE 10
REFINED METALS CORPORATION

In this year's photographs recent precipitation is apparent. In the northern portion of the site possible liquid or staining is visible. In the northwestern portion of the site the horizontal tank and the light-toned mounded material and debris remain. In the eastern portion of the site one of the two areas of liquid seen in parking areas in 1997 remains. Only one of the probable vertical tanks previously seen near the south central portion of the site remains. The probable stain or liquid seen near the south central portion of the site is no longer visible. In the southeast corner of the site the holding pond with liquid remains. Immediately southeast of the Refined Metals Corporation, near a parking area, a probable pipe is visible. The domed structure remains visible in the open storage area located in the south central portion of the site.
